# Manhole Inspection Summary

Manhole # S31AA1018MH

Insp Date: **5/21/07 2:22 PM**

**Location** Address: **SAN MARTIN DR**

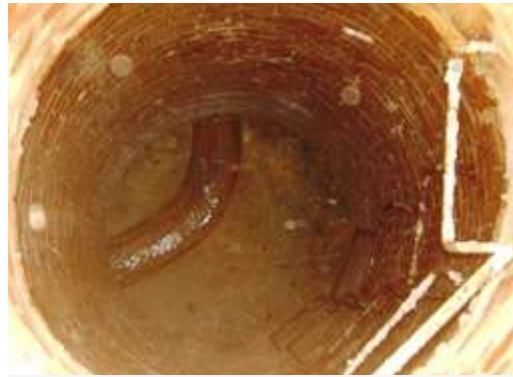
Top View

**Bench** ☒ Exists Material: **Brick** ☐ Parged ☒ **Debris** (not Condition related)

Bench debris.

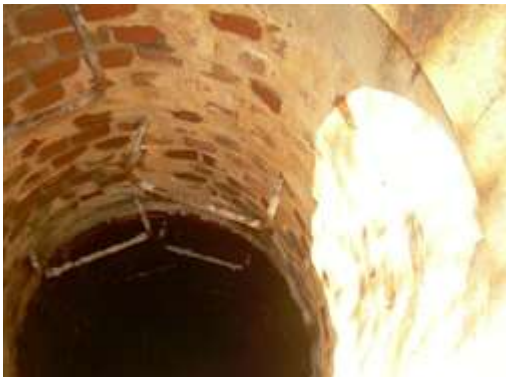
Defect

**Frame** Offset: **3** (in.) Condition: ☐ Sound ☐ Cracked ☒ **Leaks**

Infiltration: ☐ None ☒ **Joint** ☐ Cracks ☐ Mortar ☐ Roots ☒ **Wall**

Infiltration: ☐ None ☐ Joint ☐ Cracks ☒ **Mortar** ☐ Roots ☒ **Wall**

Frame leaks. Adjustment and Corbel infiltration.

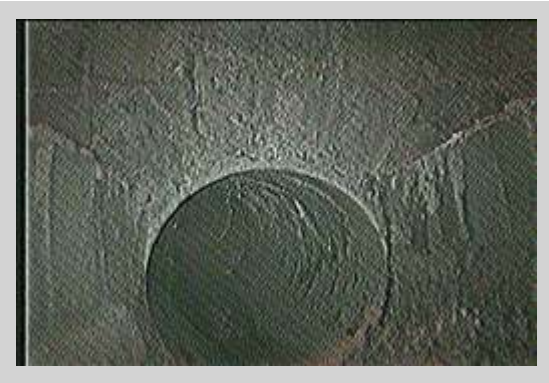
### 10 in. Circular Gravity Sewer Pipe Out @ 12 O'Clock

Pipe Material: **Clay** ☐ Pipe Lined

Invert Depth: **17.05** (ft.) Flow Characteristics: **Fast**

Infiltration: **None** Pipe Seal Cond: **Unknown**

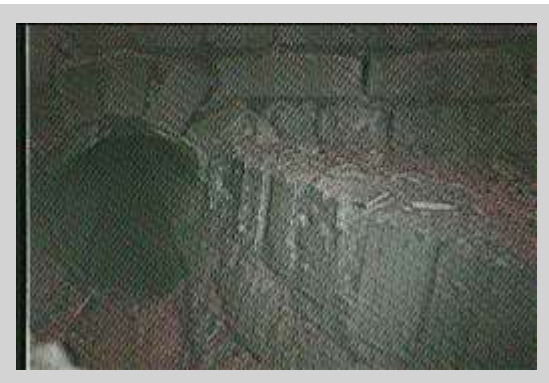
### 10 in. Circular Gravity Sewer Pipe In @ 8 O'Clock

Infiltration: **Evidence** Pipe Seal Cond: **Broken**
